Navajo Abandoned Uranium Mine Site Screen Report

Haven AUM Site

Navajo AUM Eastern Region

Weston Solutions, Inc.

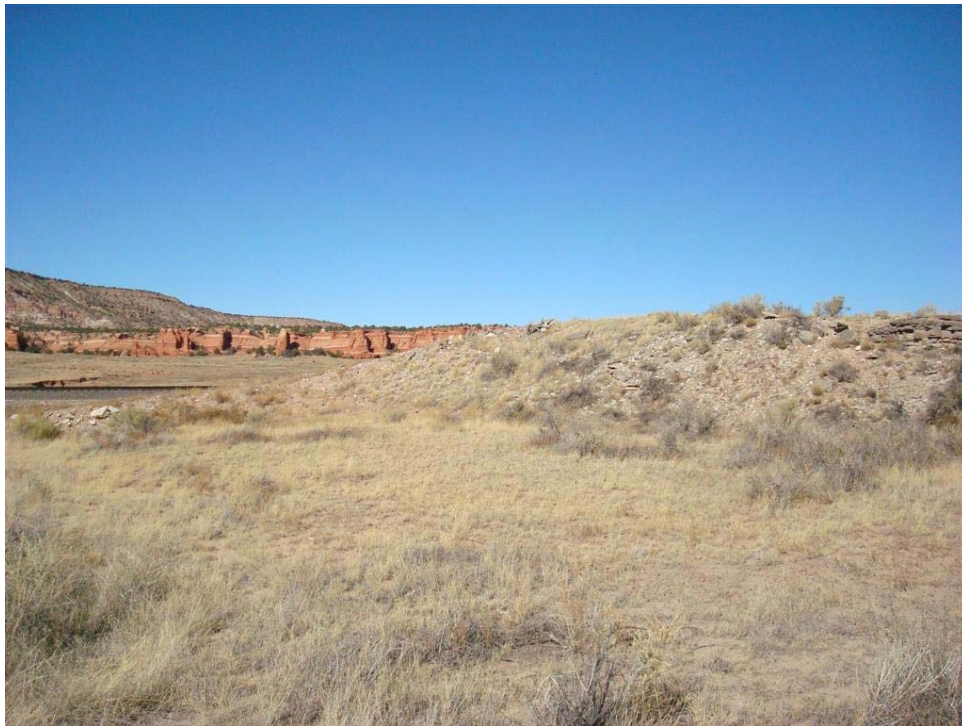
Photo 1. Haven Mine site, towards the north. Railroad in background.

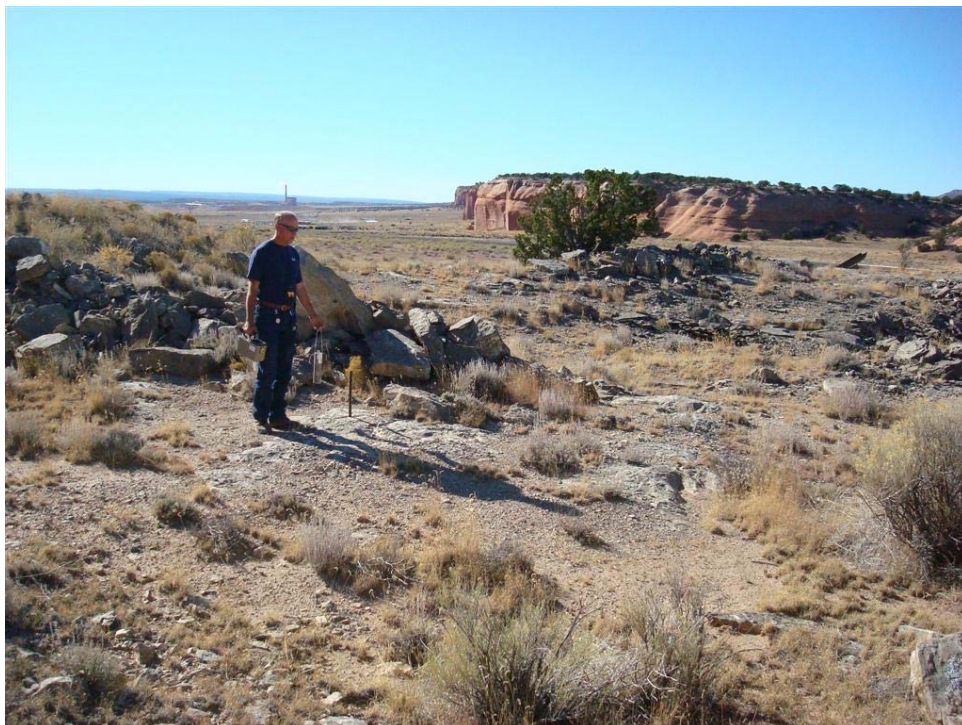
Reclamation status of the mine site is currently unknown. No visible signs of reclamation were observed. Numerous waste rock piles are found throughout the site. The mining appears to have been conducted from exposed bedrock at the surface. A wooden chute remains at the southern edge of the mine. Blast holes were found in some areas. No adits or other mine features were observed during the site visit.

Photo 2. Haven Mine site, towards the northwest
Waste rock piles and drill steel in bedrock

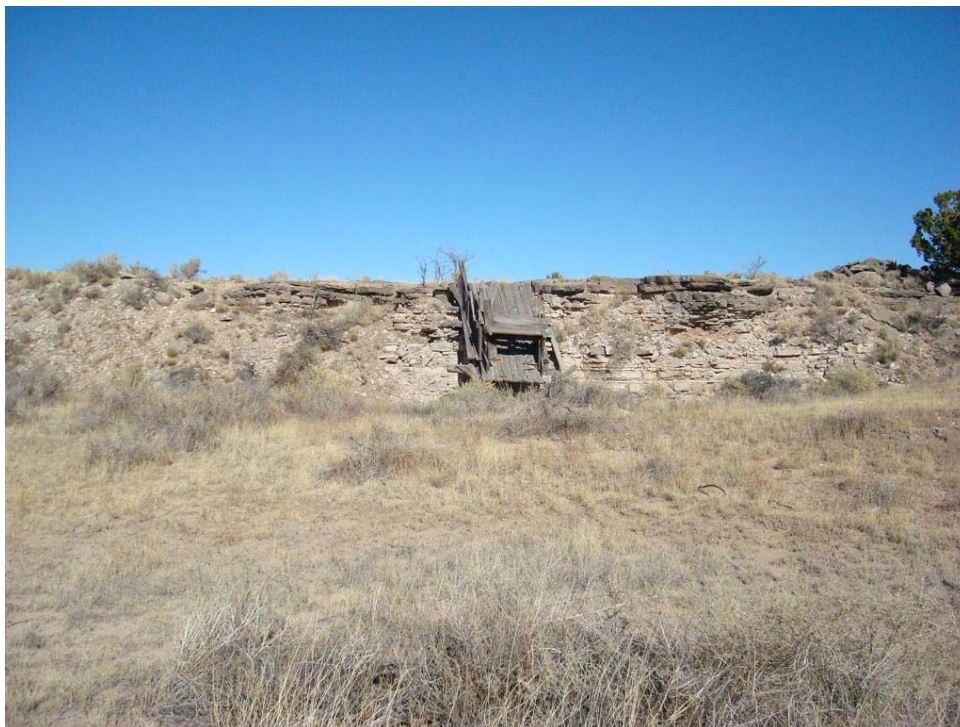
Photo 3. Haven Mine site with wooden chute at west end of mine

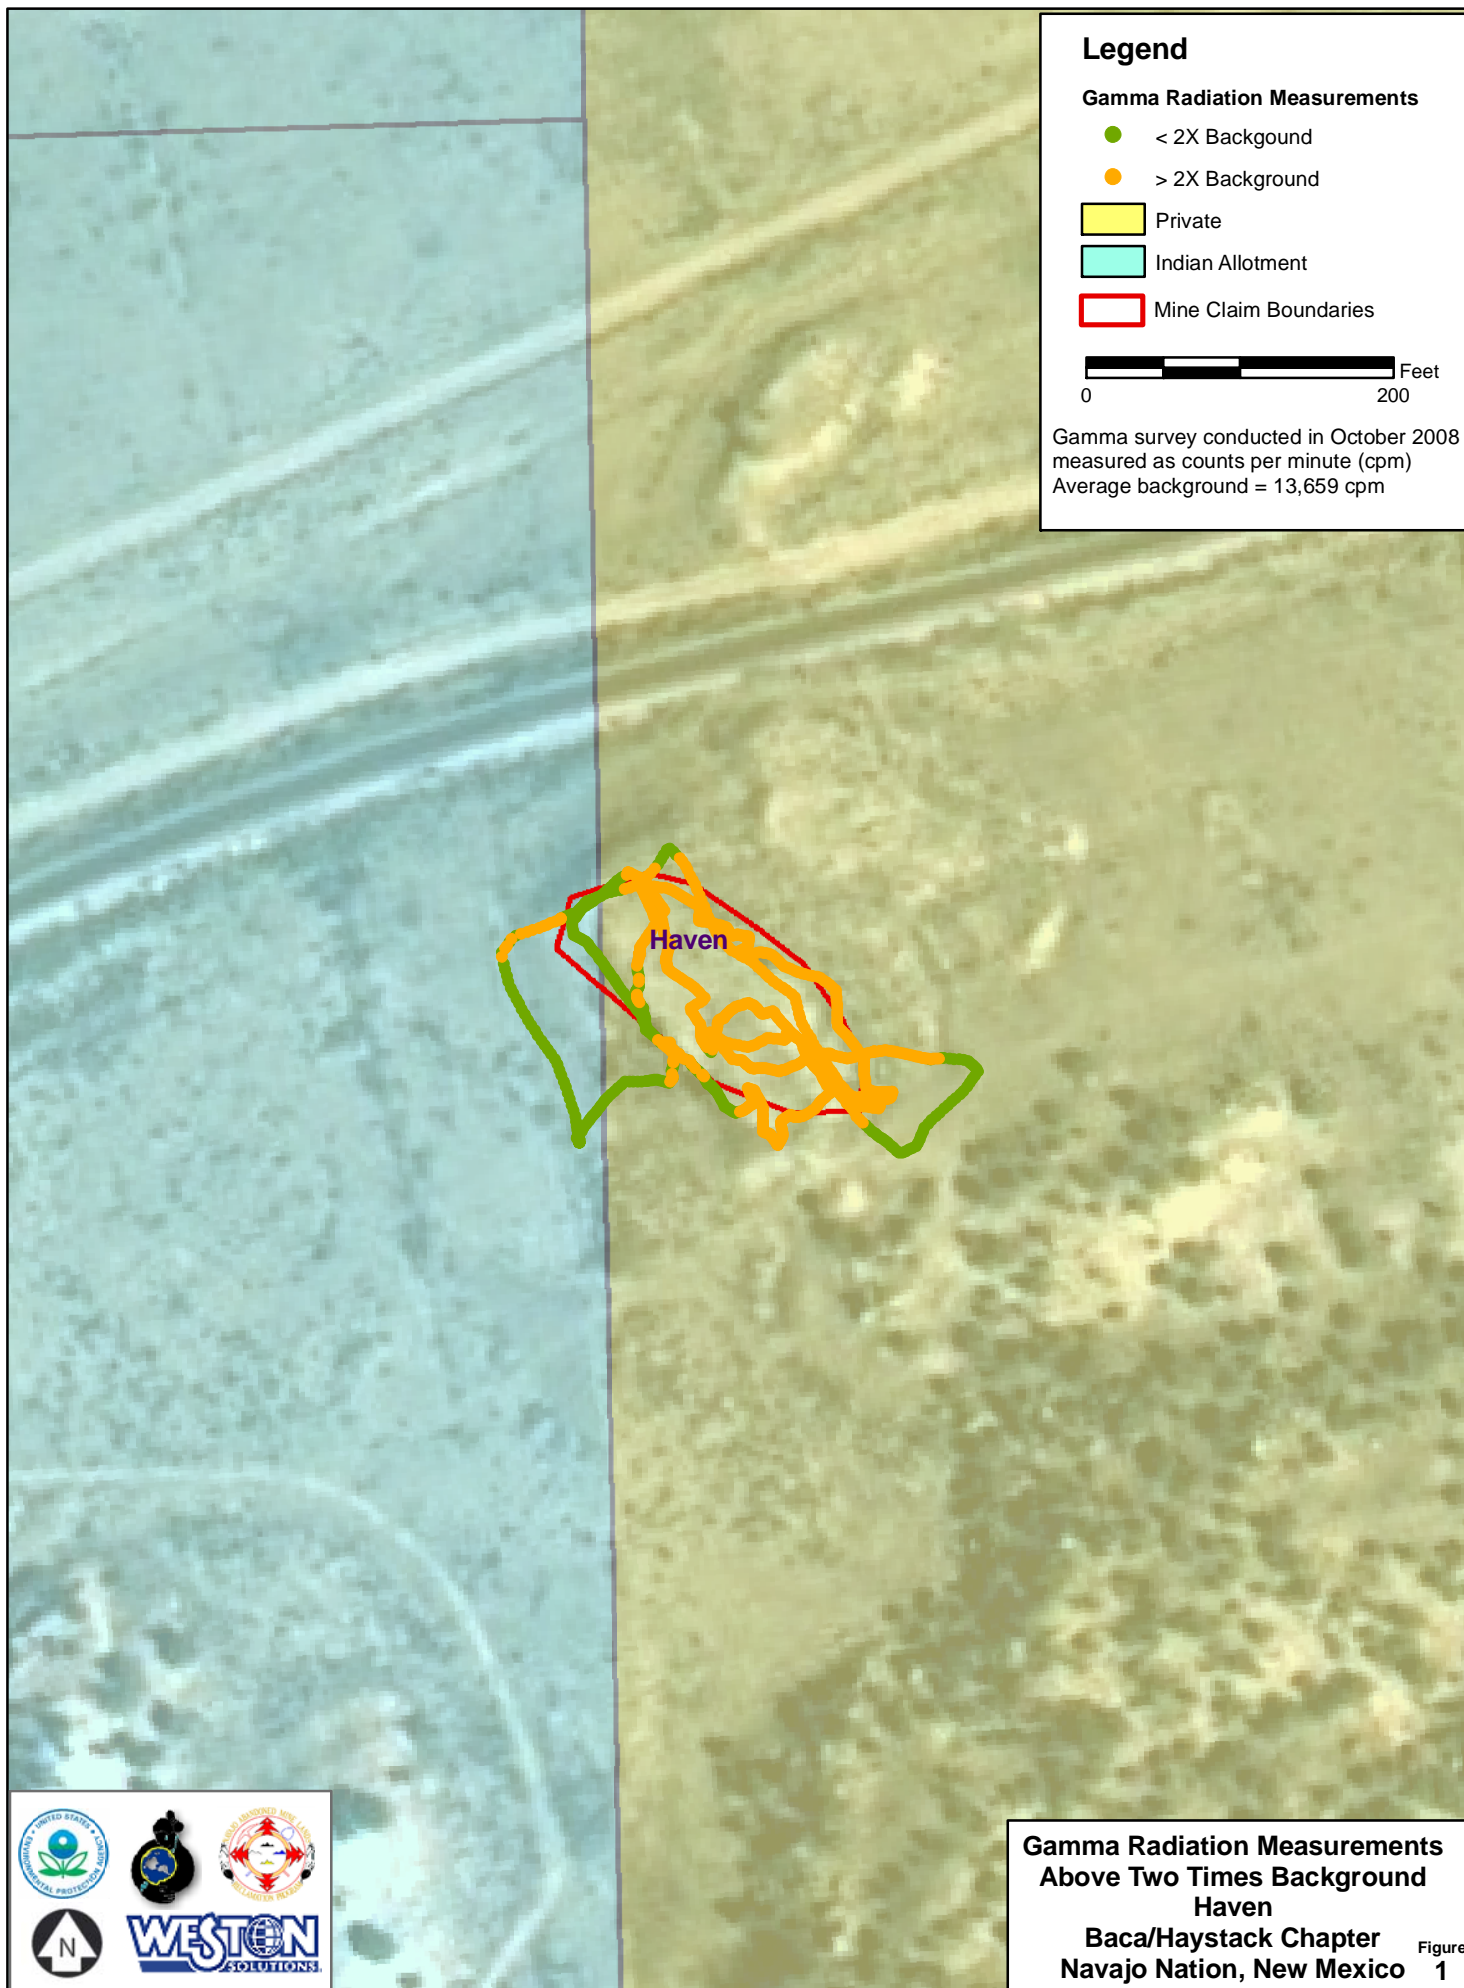
A total of 1,348 gamma radiation measurements were collected from mine sites, ranging from 10,670 cpm to 356,709 cpm. The measurements are represented in Figures 1 and 2.

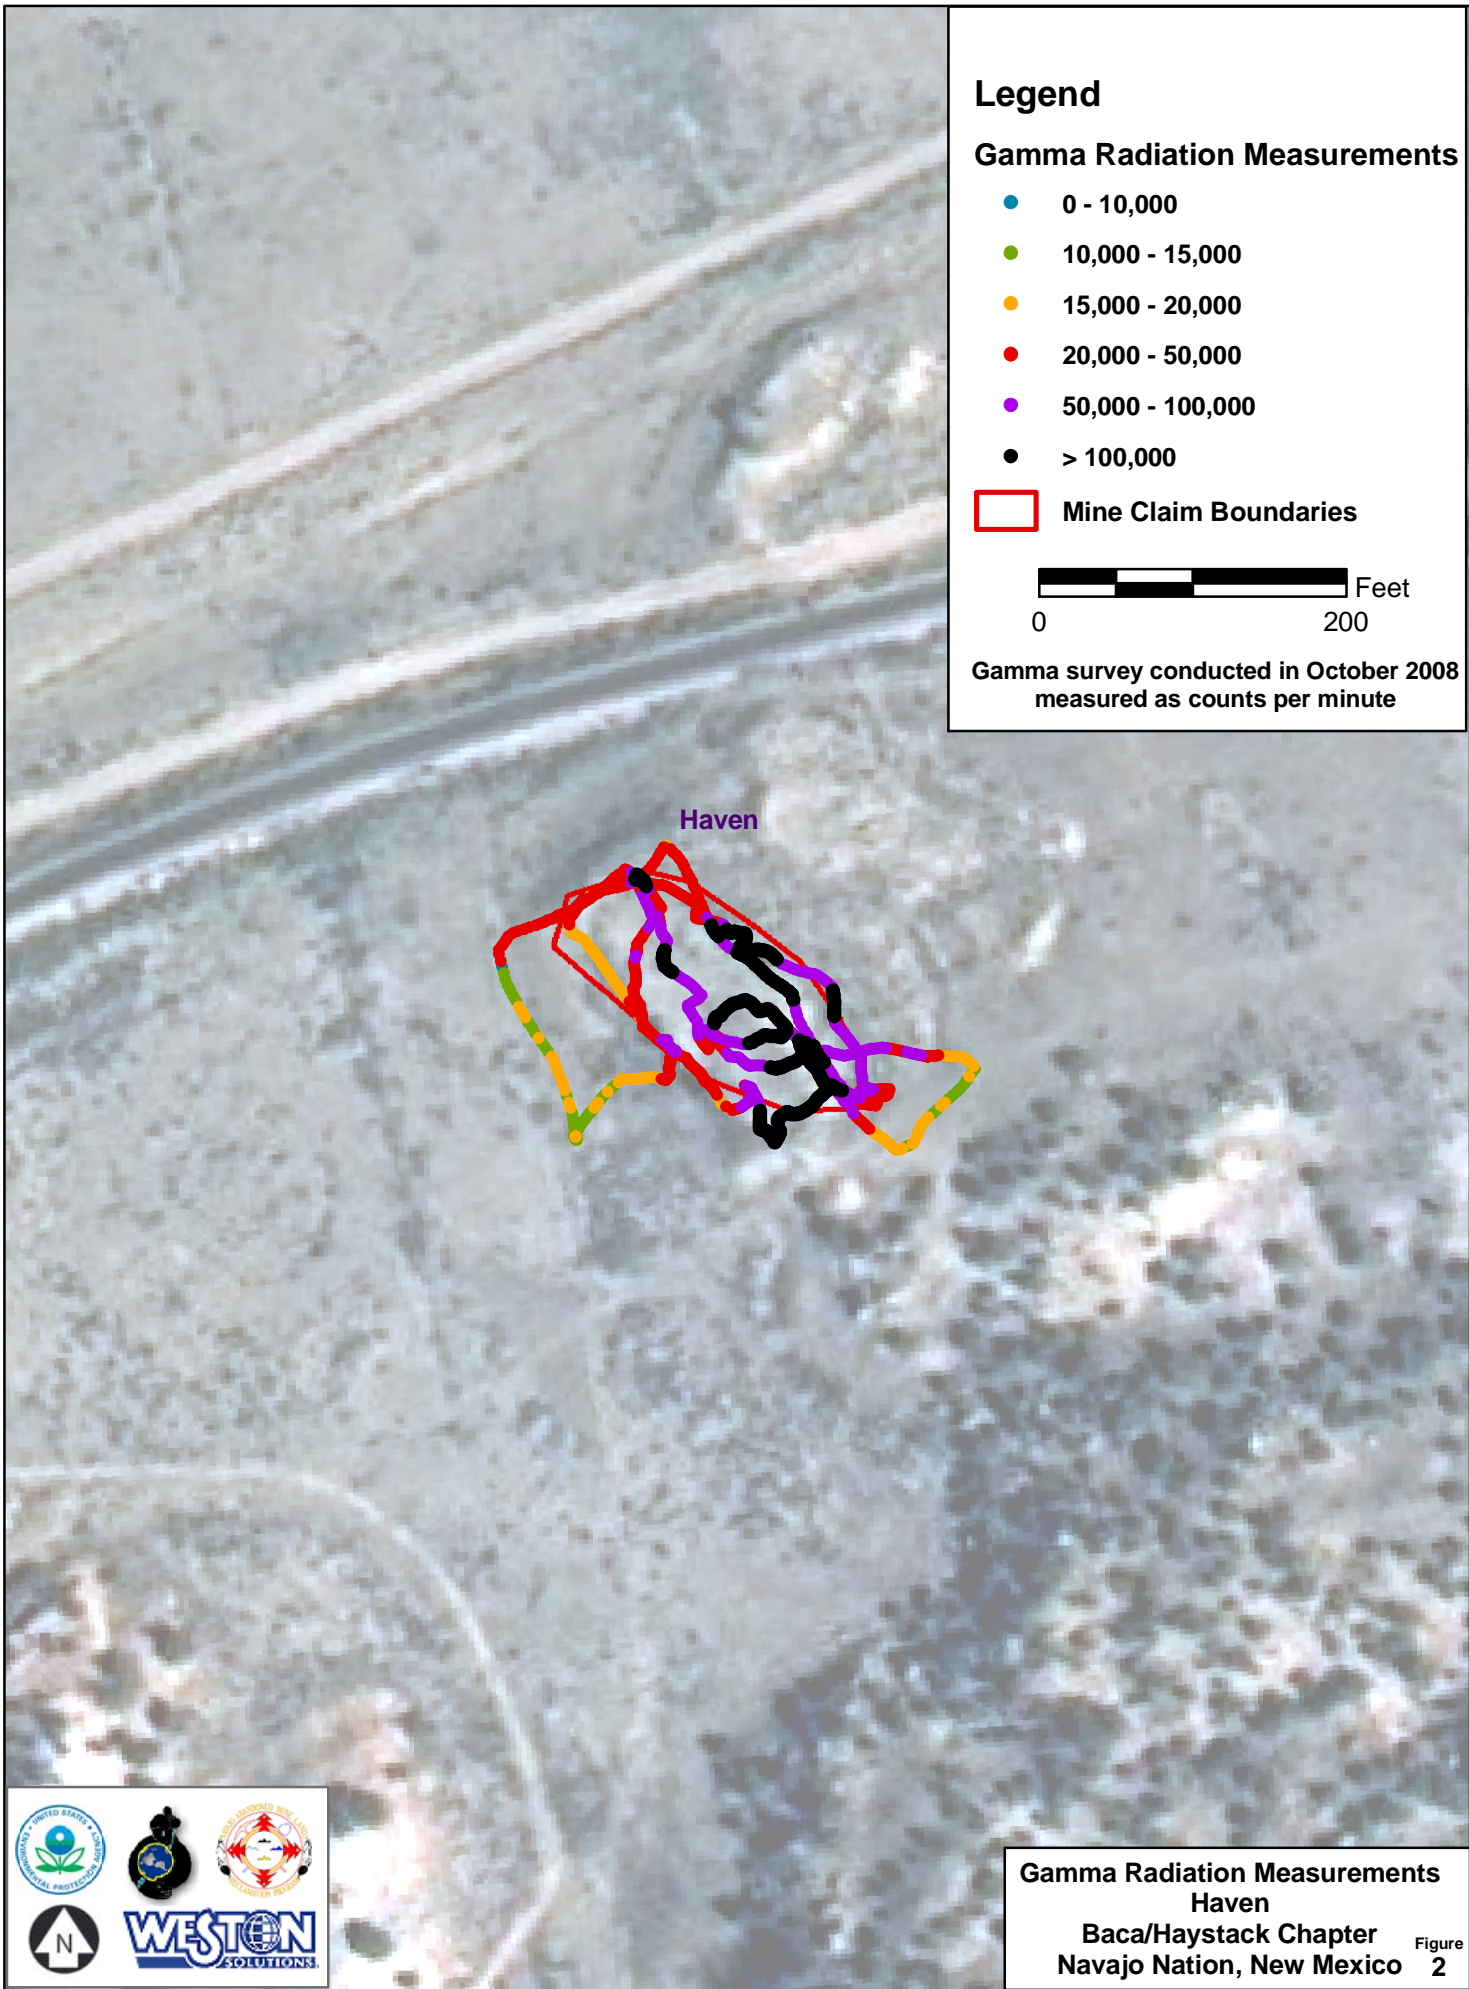
Figure
2

**Gamma Radiation Measurements
Haven
Baca/Haystack Chapter
Navajo Nation, New Mexico**
